Disconnecting Thermal Sensor

The new OSET 24.0 models feature a sensor to monitor motor temperatures. The temperature readings are communicated to the controller, and the controller in turn reduces power if the temperature is too high. In normal riding conditions this sensor will never cut in, so has proven to be an un-necessary feature.

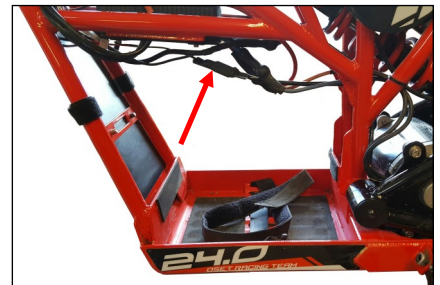
1. Remove side panels and locate the connector that is protected with heat shrink.

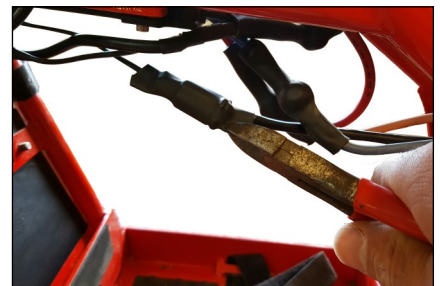
2. Remove the heat shrink with cutters.

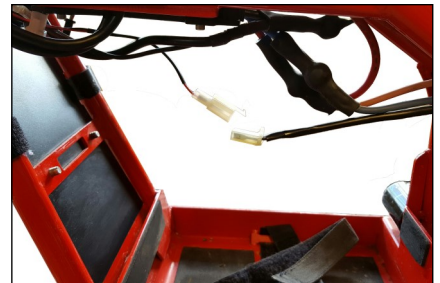
3. Disconnect the thermal sensor

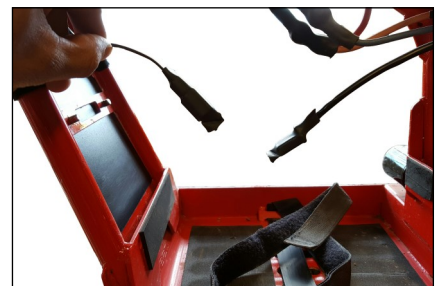
4. Seal both connectors with something suitable, such as heat shrink and cable tie out of the way.
